Limited Visual Dam Safety Inspection Summary Report

MA-082

HC&S Reservoir 70

Limited Visual Dam Safety Inspection Conducted on: 04 April 2006

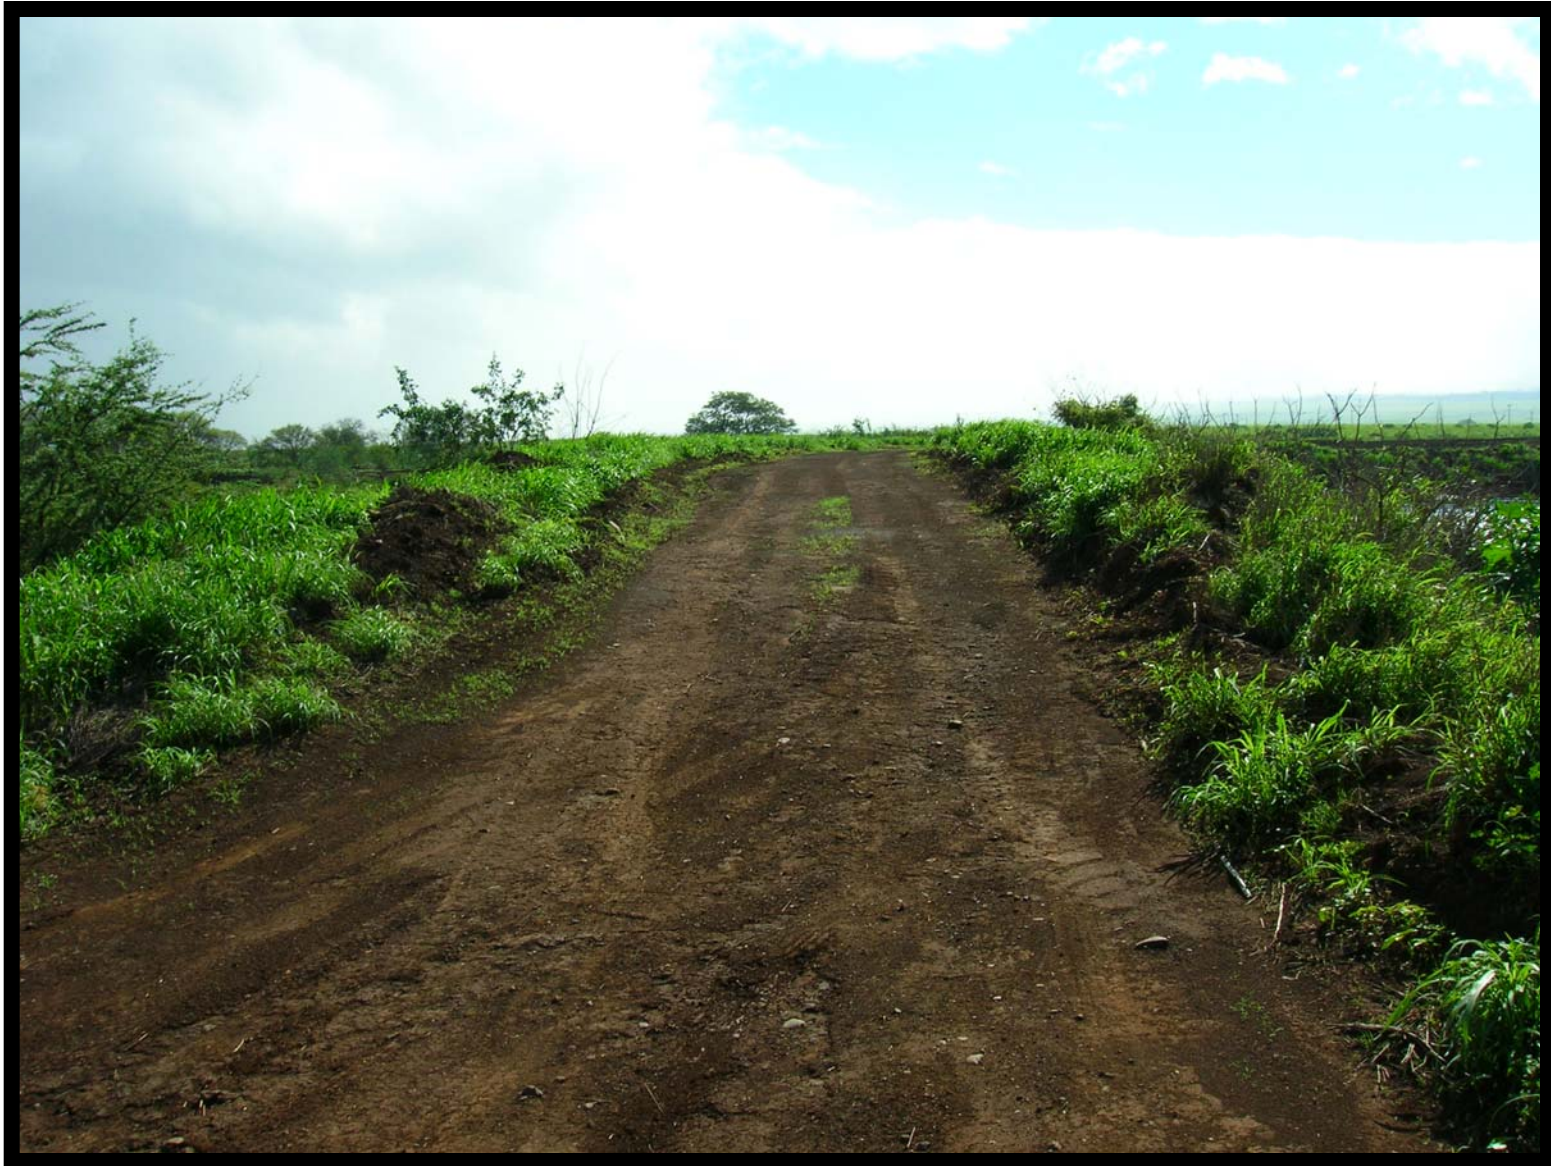
082 crest

- a. The dam crest appeared to be in satisfactory condition, no corrective actions are required at this time.

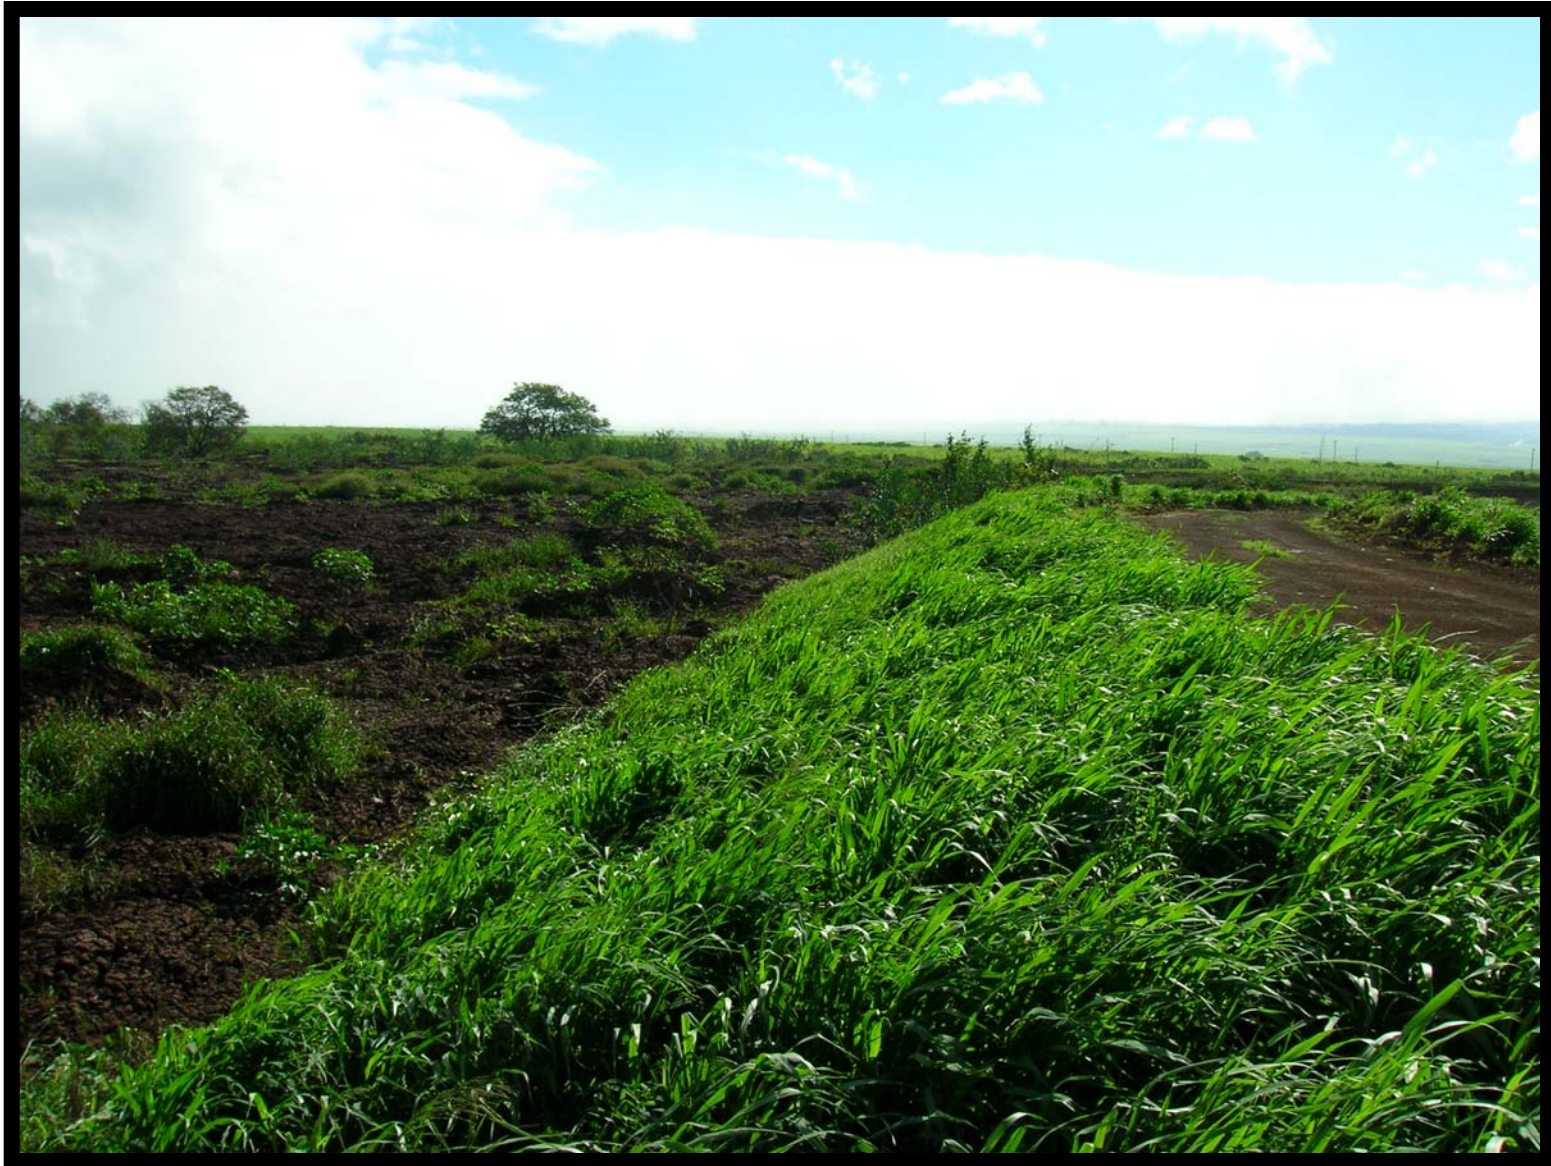
082 downstream slope

The downstream slope was in fair to poor condition and not visible due to heavy vegetation. The slope was very steep, between 2 on 0.5 to 2 on 1 slope.

Vegetation and trees were observed on the downstream slope.

- a. The downstream slope appeared to be in fair to poor condition and requires corrective action.
- b. The down stream slope was not visible due to high grass and bush vegetation. Clear high vegetation and maintain low to enable easy visual inspection.

- c. Tree(s) were observed on the downstream slope. Trees have been identified as the probably cause of piping failures, and can possibly cause sever damage to the embankment if they are uprooted during a high winds. Corrective action is required to remove the tree hazards from the dam. Acceptable remedies include removal of the tree and its root structure down to a 2" diameter and reconstructing the damaged embankment section. All repair work shall be accomplished as per the requirements of licensed geotechnical or structural engineer. Routinely monitor the damaged area for signs of settlement and seepage.

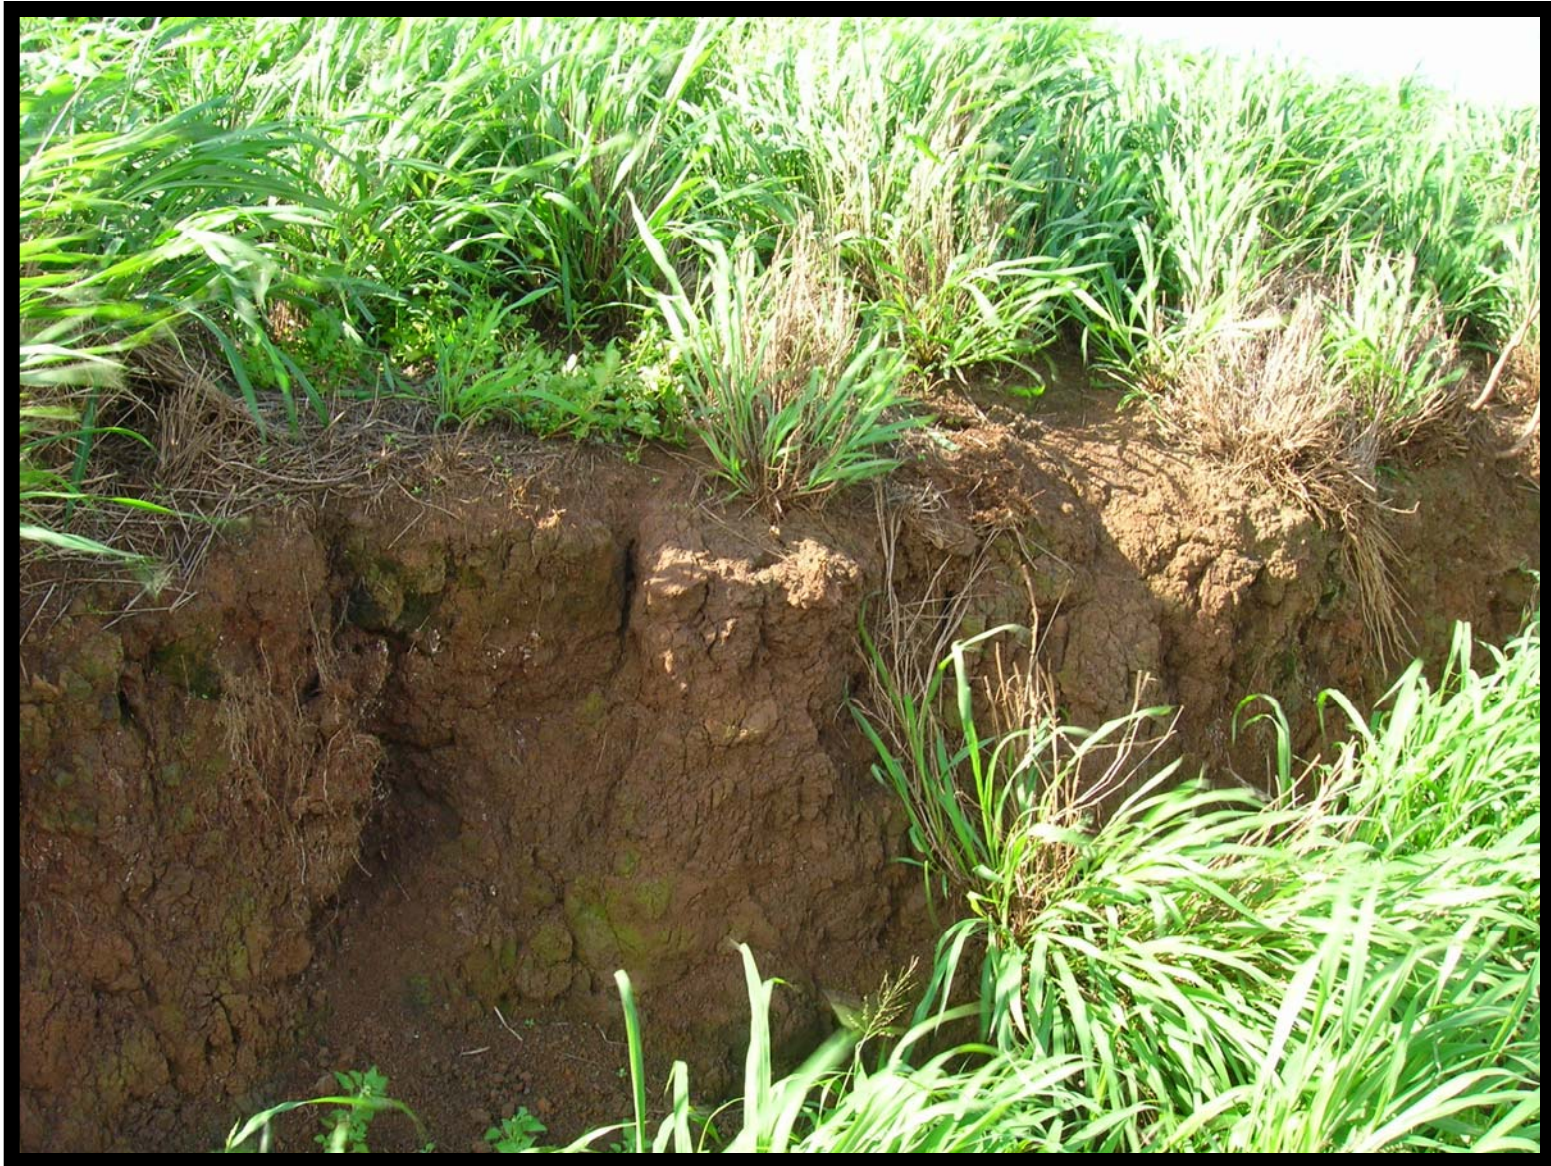
082 downstream toe scarp

- a. The abutments/toe appeared to be in fair to poor condition and requires corrective action.
- b. The abutment/toe area was not visible due to high grass and bush vegetation. Clear high vegetation and maintain low to enable easy visual inspection.
- c. Tree(s) were observed on the downstream slope. Trees have been identified as the probably cause of piping failures, and can possibly cause sever damage to the embankment if they are uprooted during a high winds. Corrective action is required to remove the tree hazards from the dam. Acceptable remedies include removal of the tree and its root structure down to a 2" diameter and reconstructing the damaged embankment section. All repair work shall be accomplished as per the requirements of licensed geotechnical or structural

engineer. Routinely monitor the damaged area for signs of settlement and seepage.

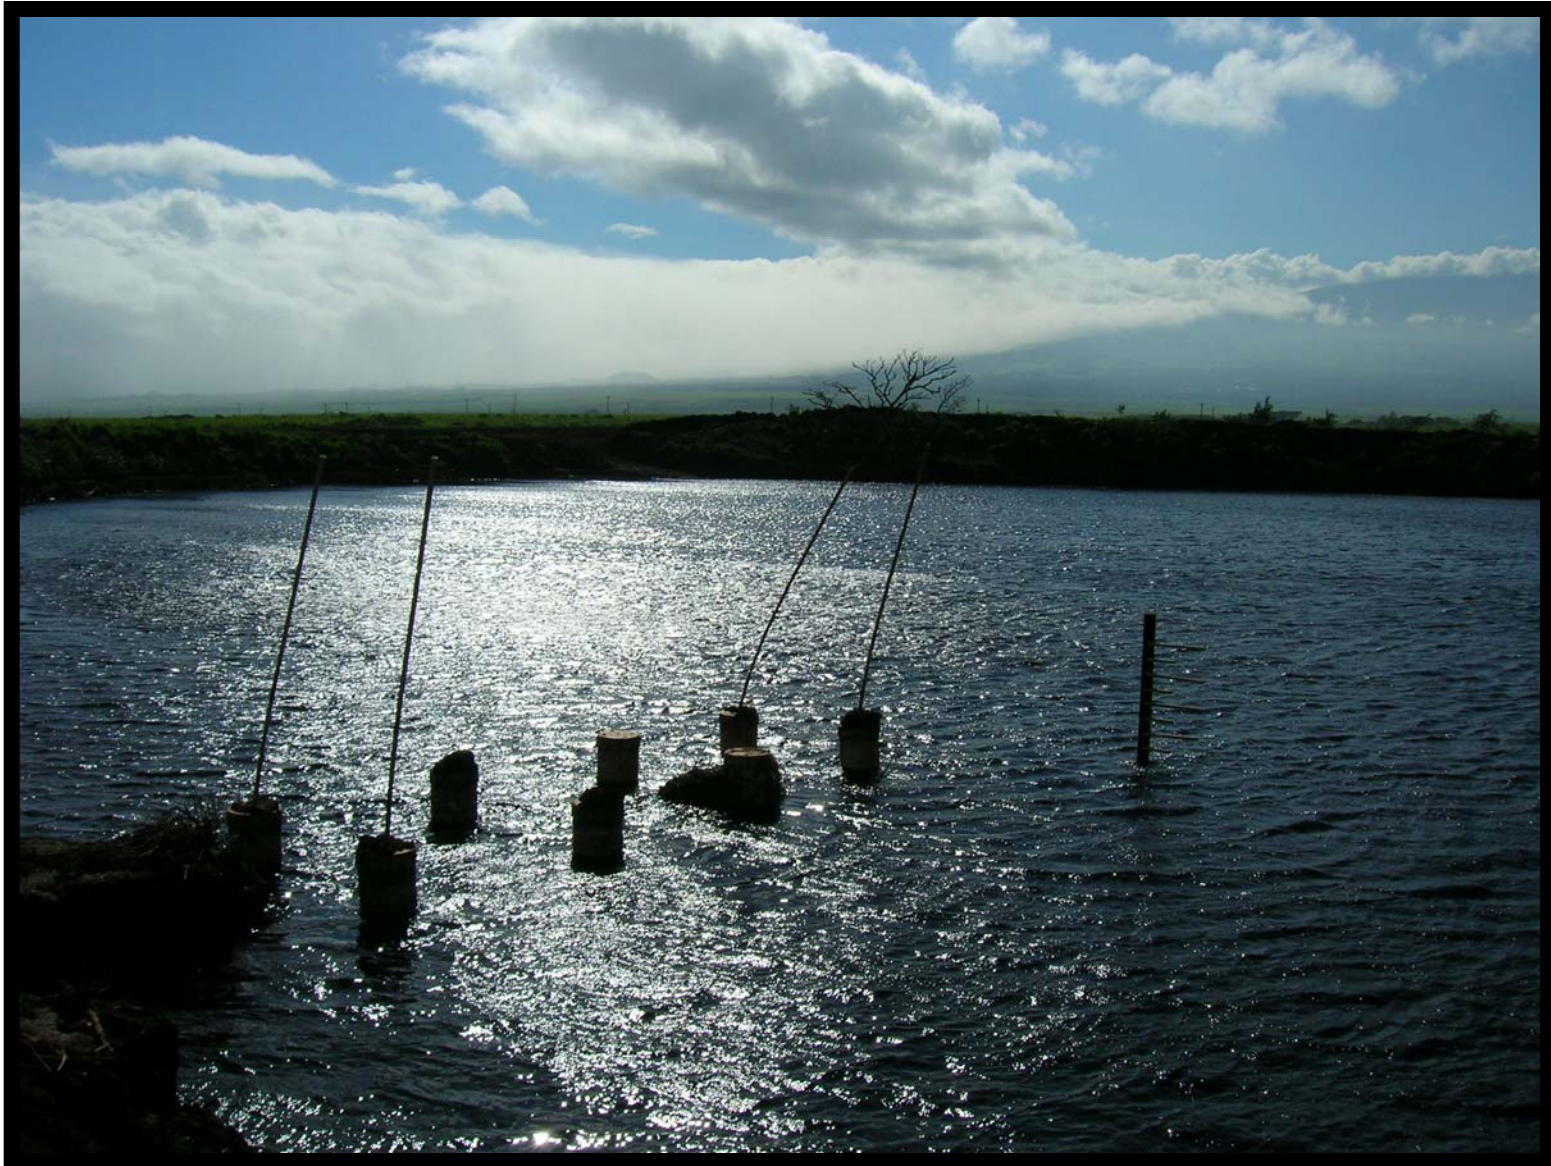
082 gage

A PVC staff gage was observed

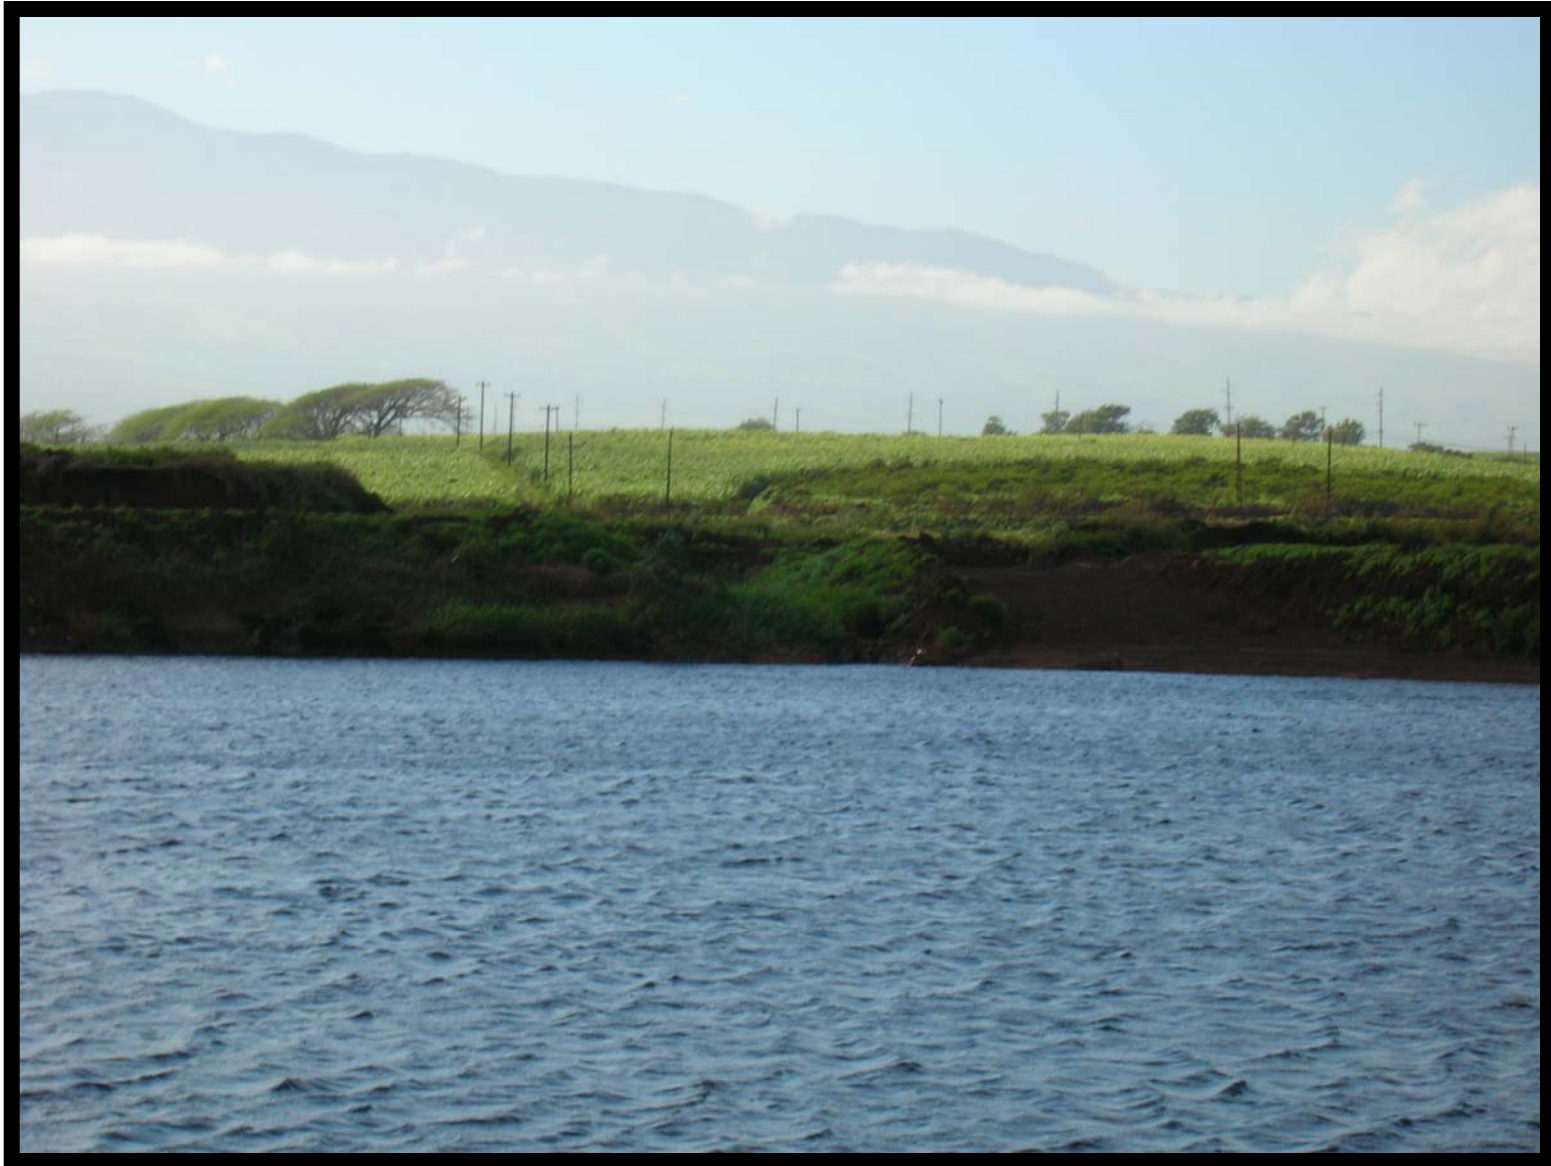
082 inlet

- a. The intake works were not inspected.
- b. The intake works were not tested.
- c. The intake works appeared to be in satisfactory condition, no corrective actions are required at this time.

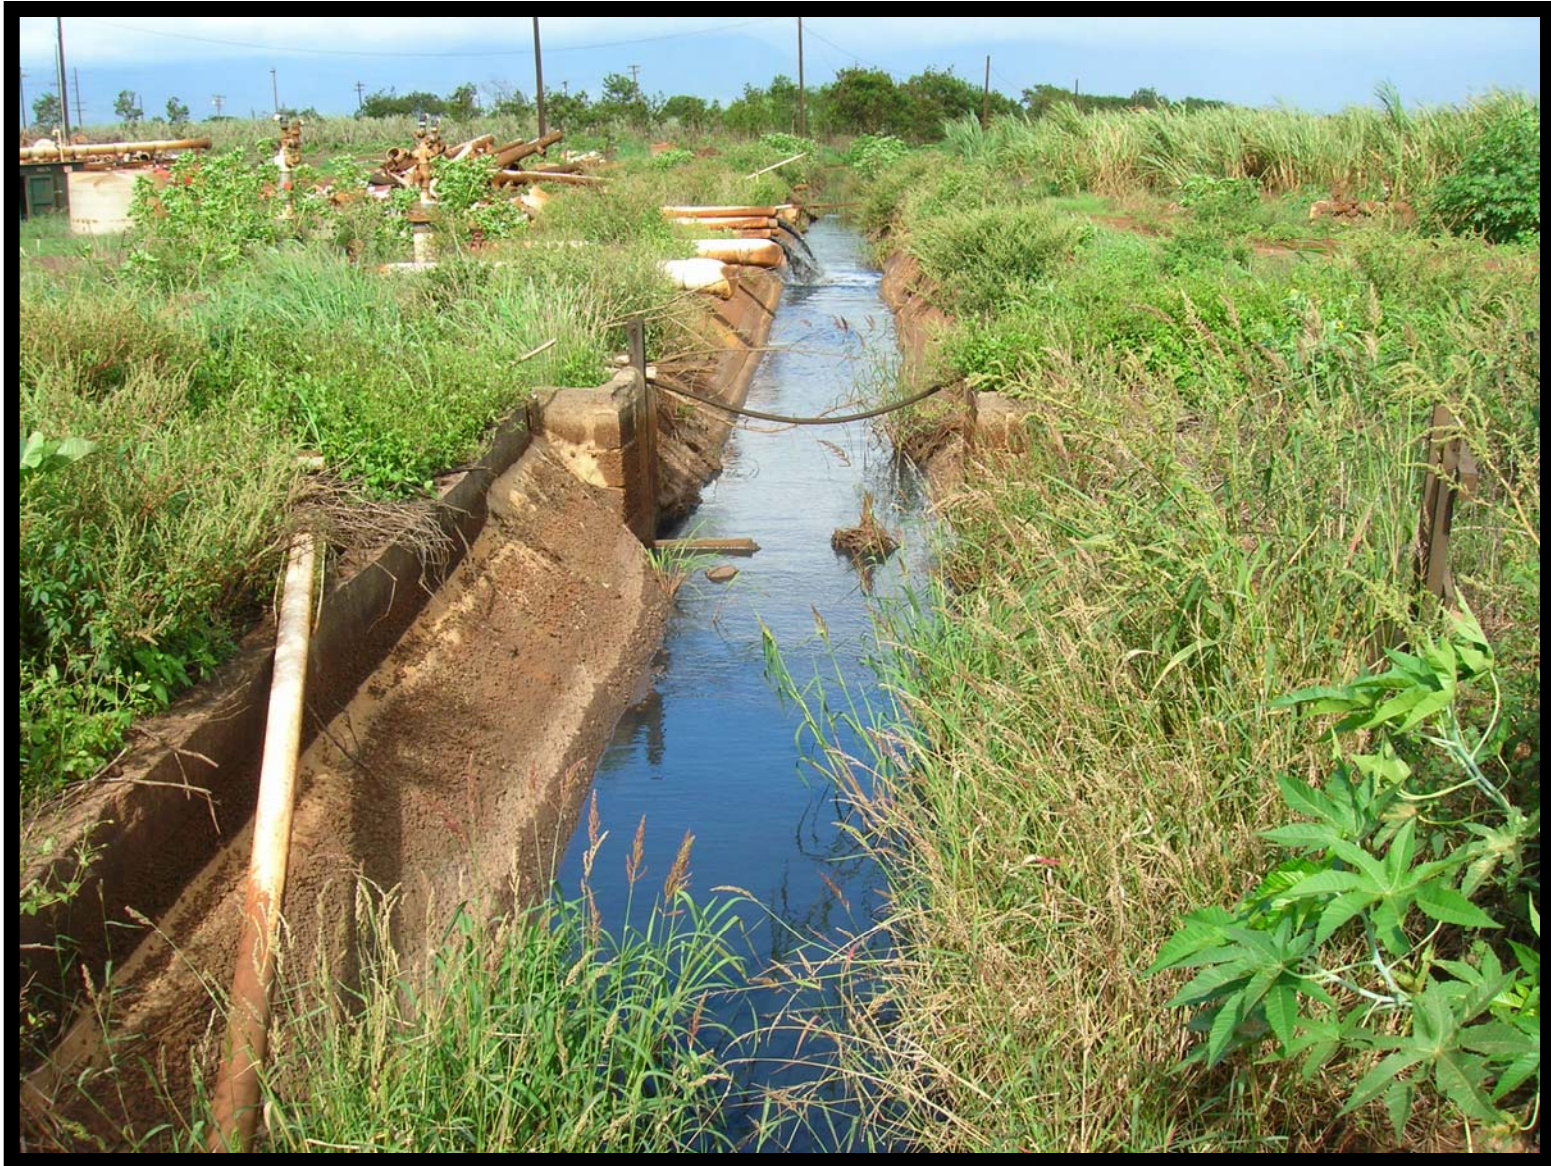
082 outlet ditch

- The downstream channel was not inspected.
- The downstream channel appeared to be in fair to poor condition and requires corrective action.
- Clean downstream channel – filled in with silt.

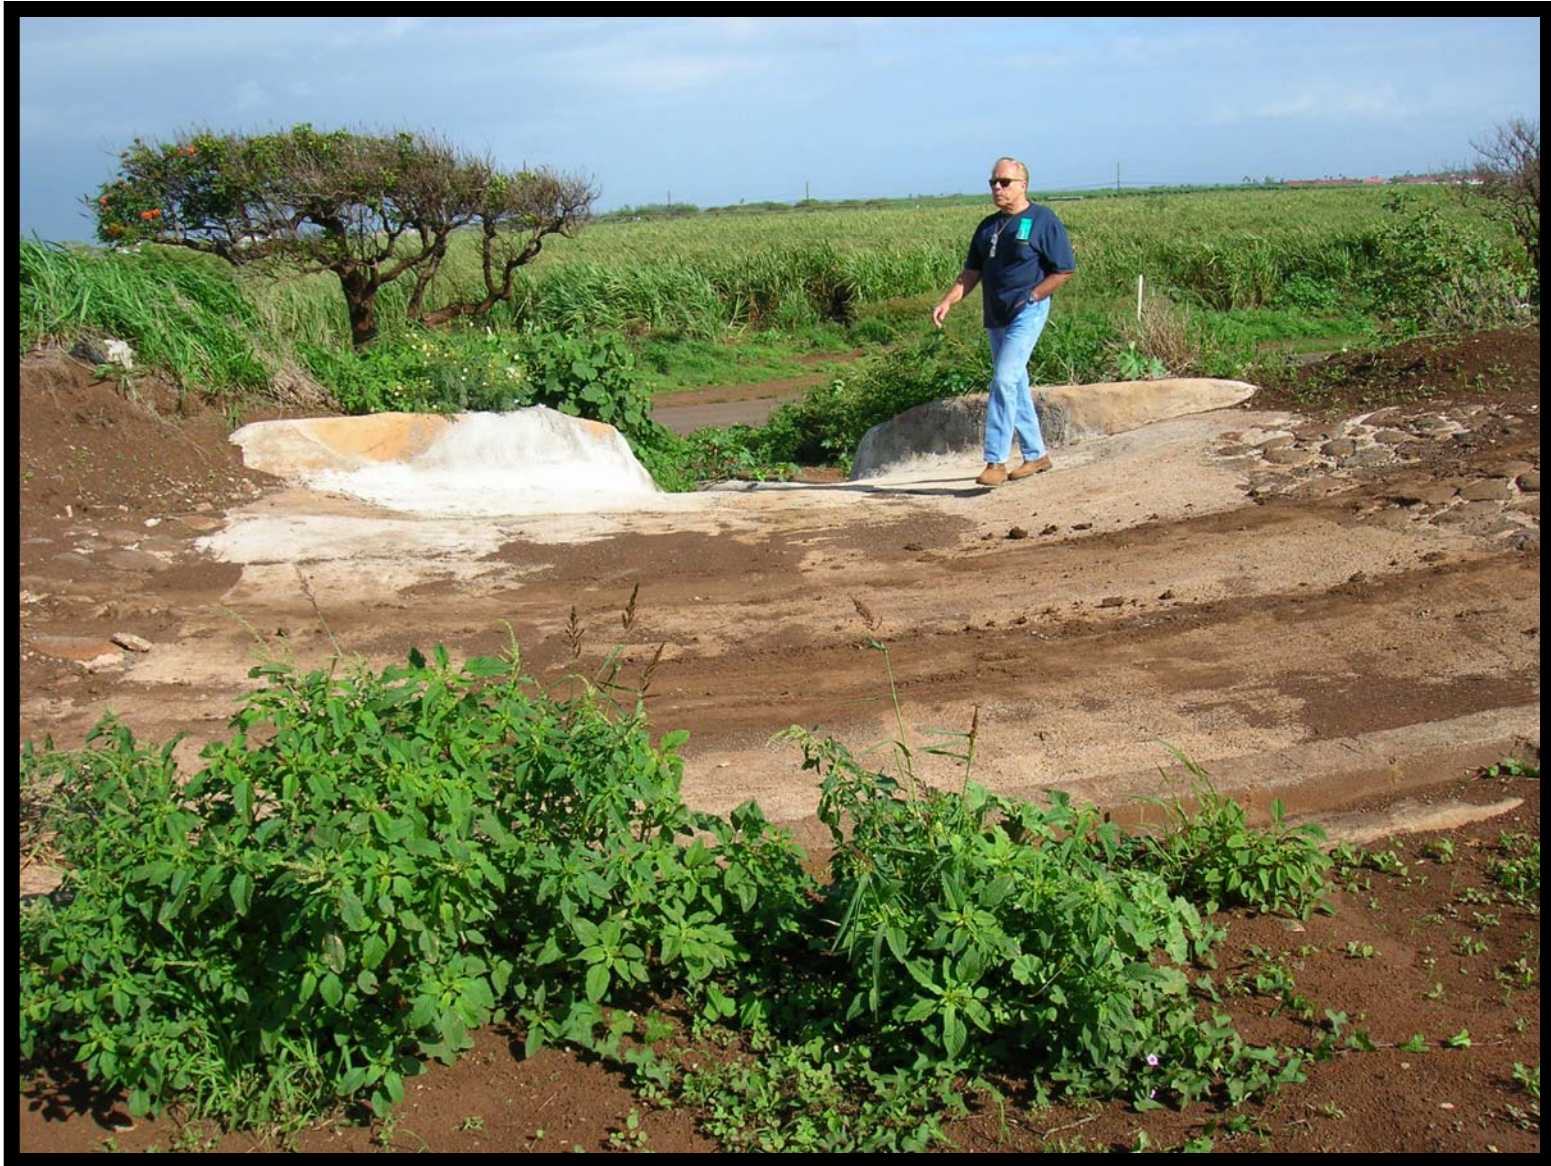
082 spillway

- The spillway appeared to be in fair to poor condition and requires corrective action.
- Unclear if spillway is adequately sized. Spillway should pass the probable maximum flood. Verify spillway capacity and take corrective action as required.
- It appears flow could easily cross busy roads downstream of dam.

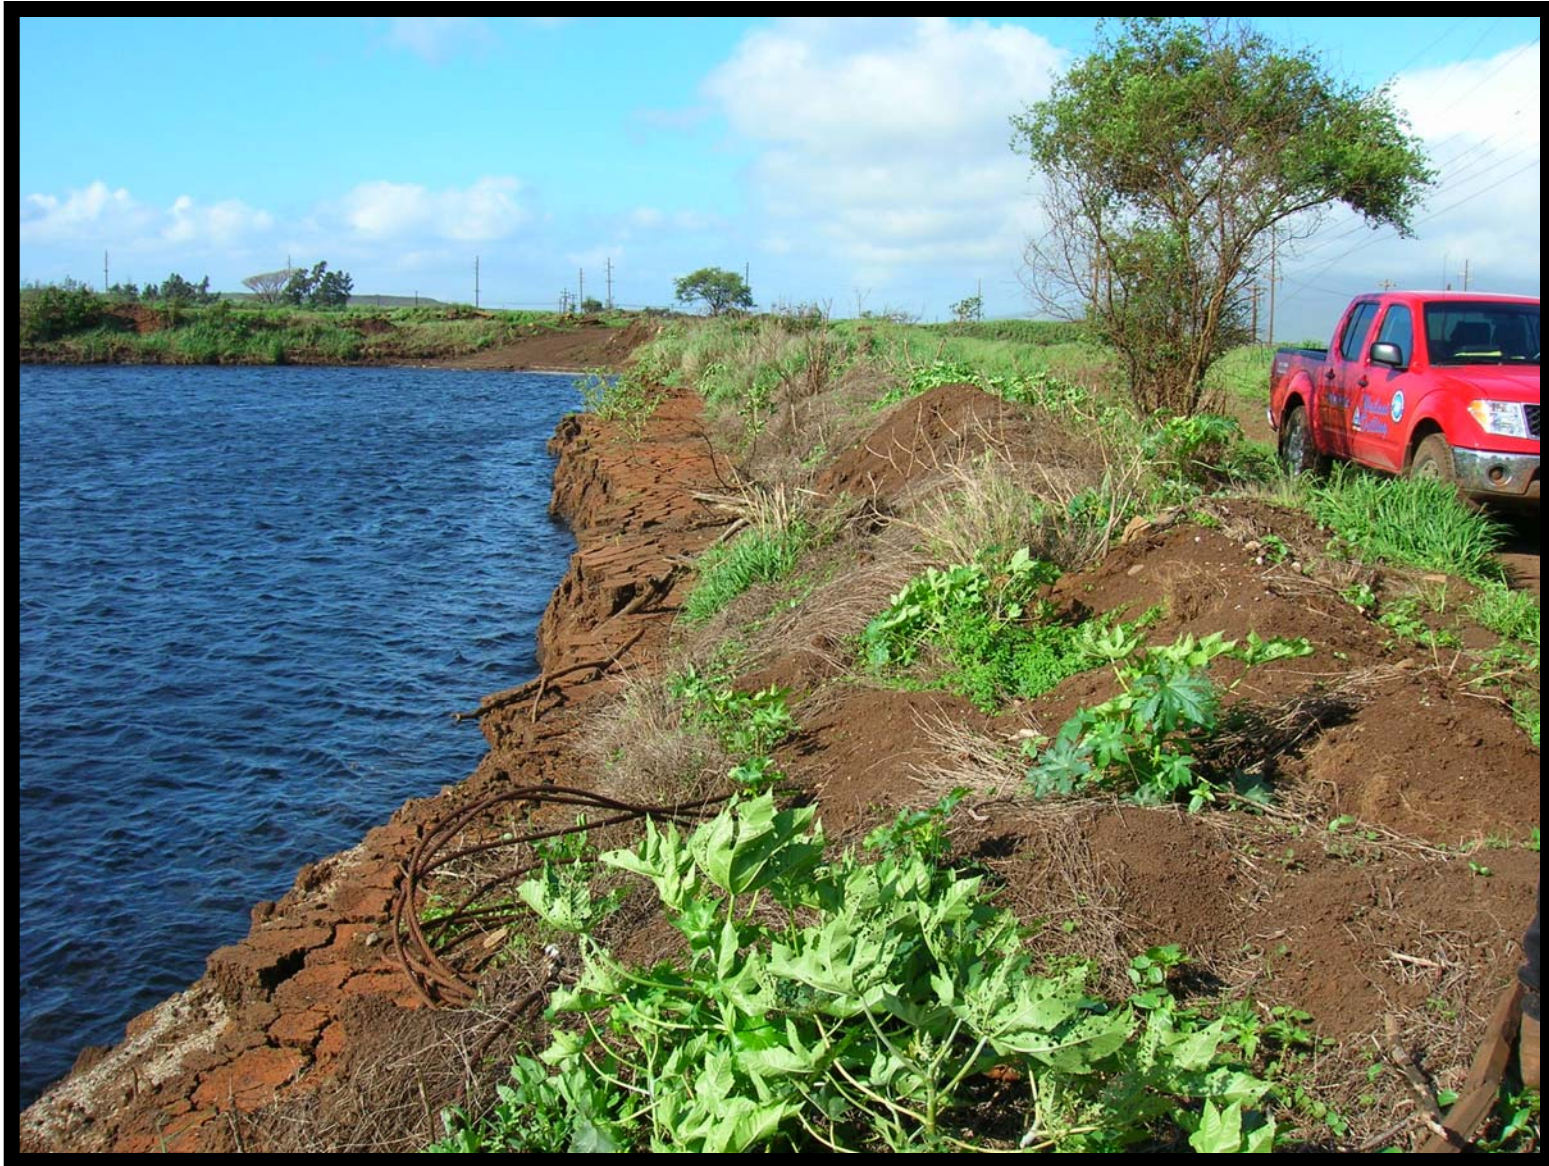
082 upstream slope

No slope protection was observed.

- a. The upstream slope appeared to be in fair to poor condition and requires corrective action.
- b. The upstream slope was not visible due to high grass and bush vegetation. Clear high vegetation and maintain low to enable easy visual inspection.
- c. Tree(s) were observed on the dam embankment. Trees have been identified as the probably cause of piping failures, and can possibly cause sever damage to the embankment if they are uprooted during a high winds. Corrective action is required to remove the tree hazards from the dam. Acceptable remedies include removal of the tree and its root structure down to a 2" diameter and reconstructing the damaged embankment section. All repair work shall be accomplished as per the requirements of licensed geotechnical or structural engineer. Routinely monitor the damaged area for signs of settlement and seepage.
